Atlantic Richfield Company

April 6, 2017

**Subject: Proposed 2017 Snowmelt Runoff Monitoring and
Modifications to Evaporation Pan Monitoring Program**
Leviathan Mine Site
Alpine County, California

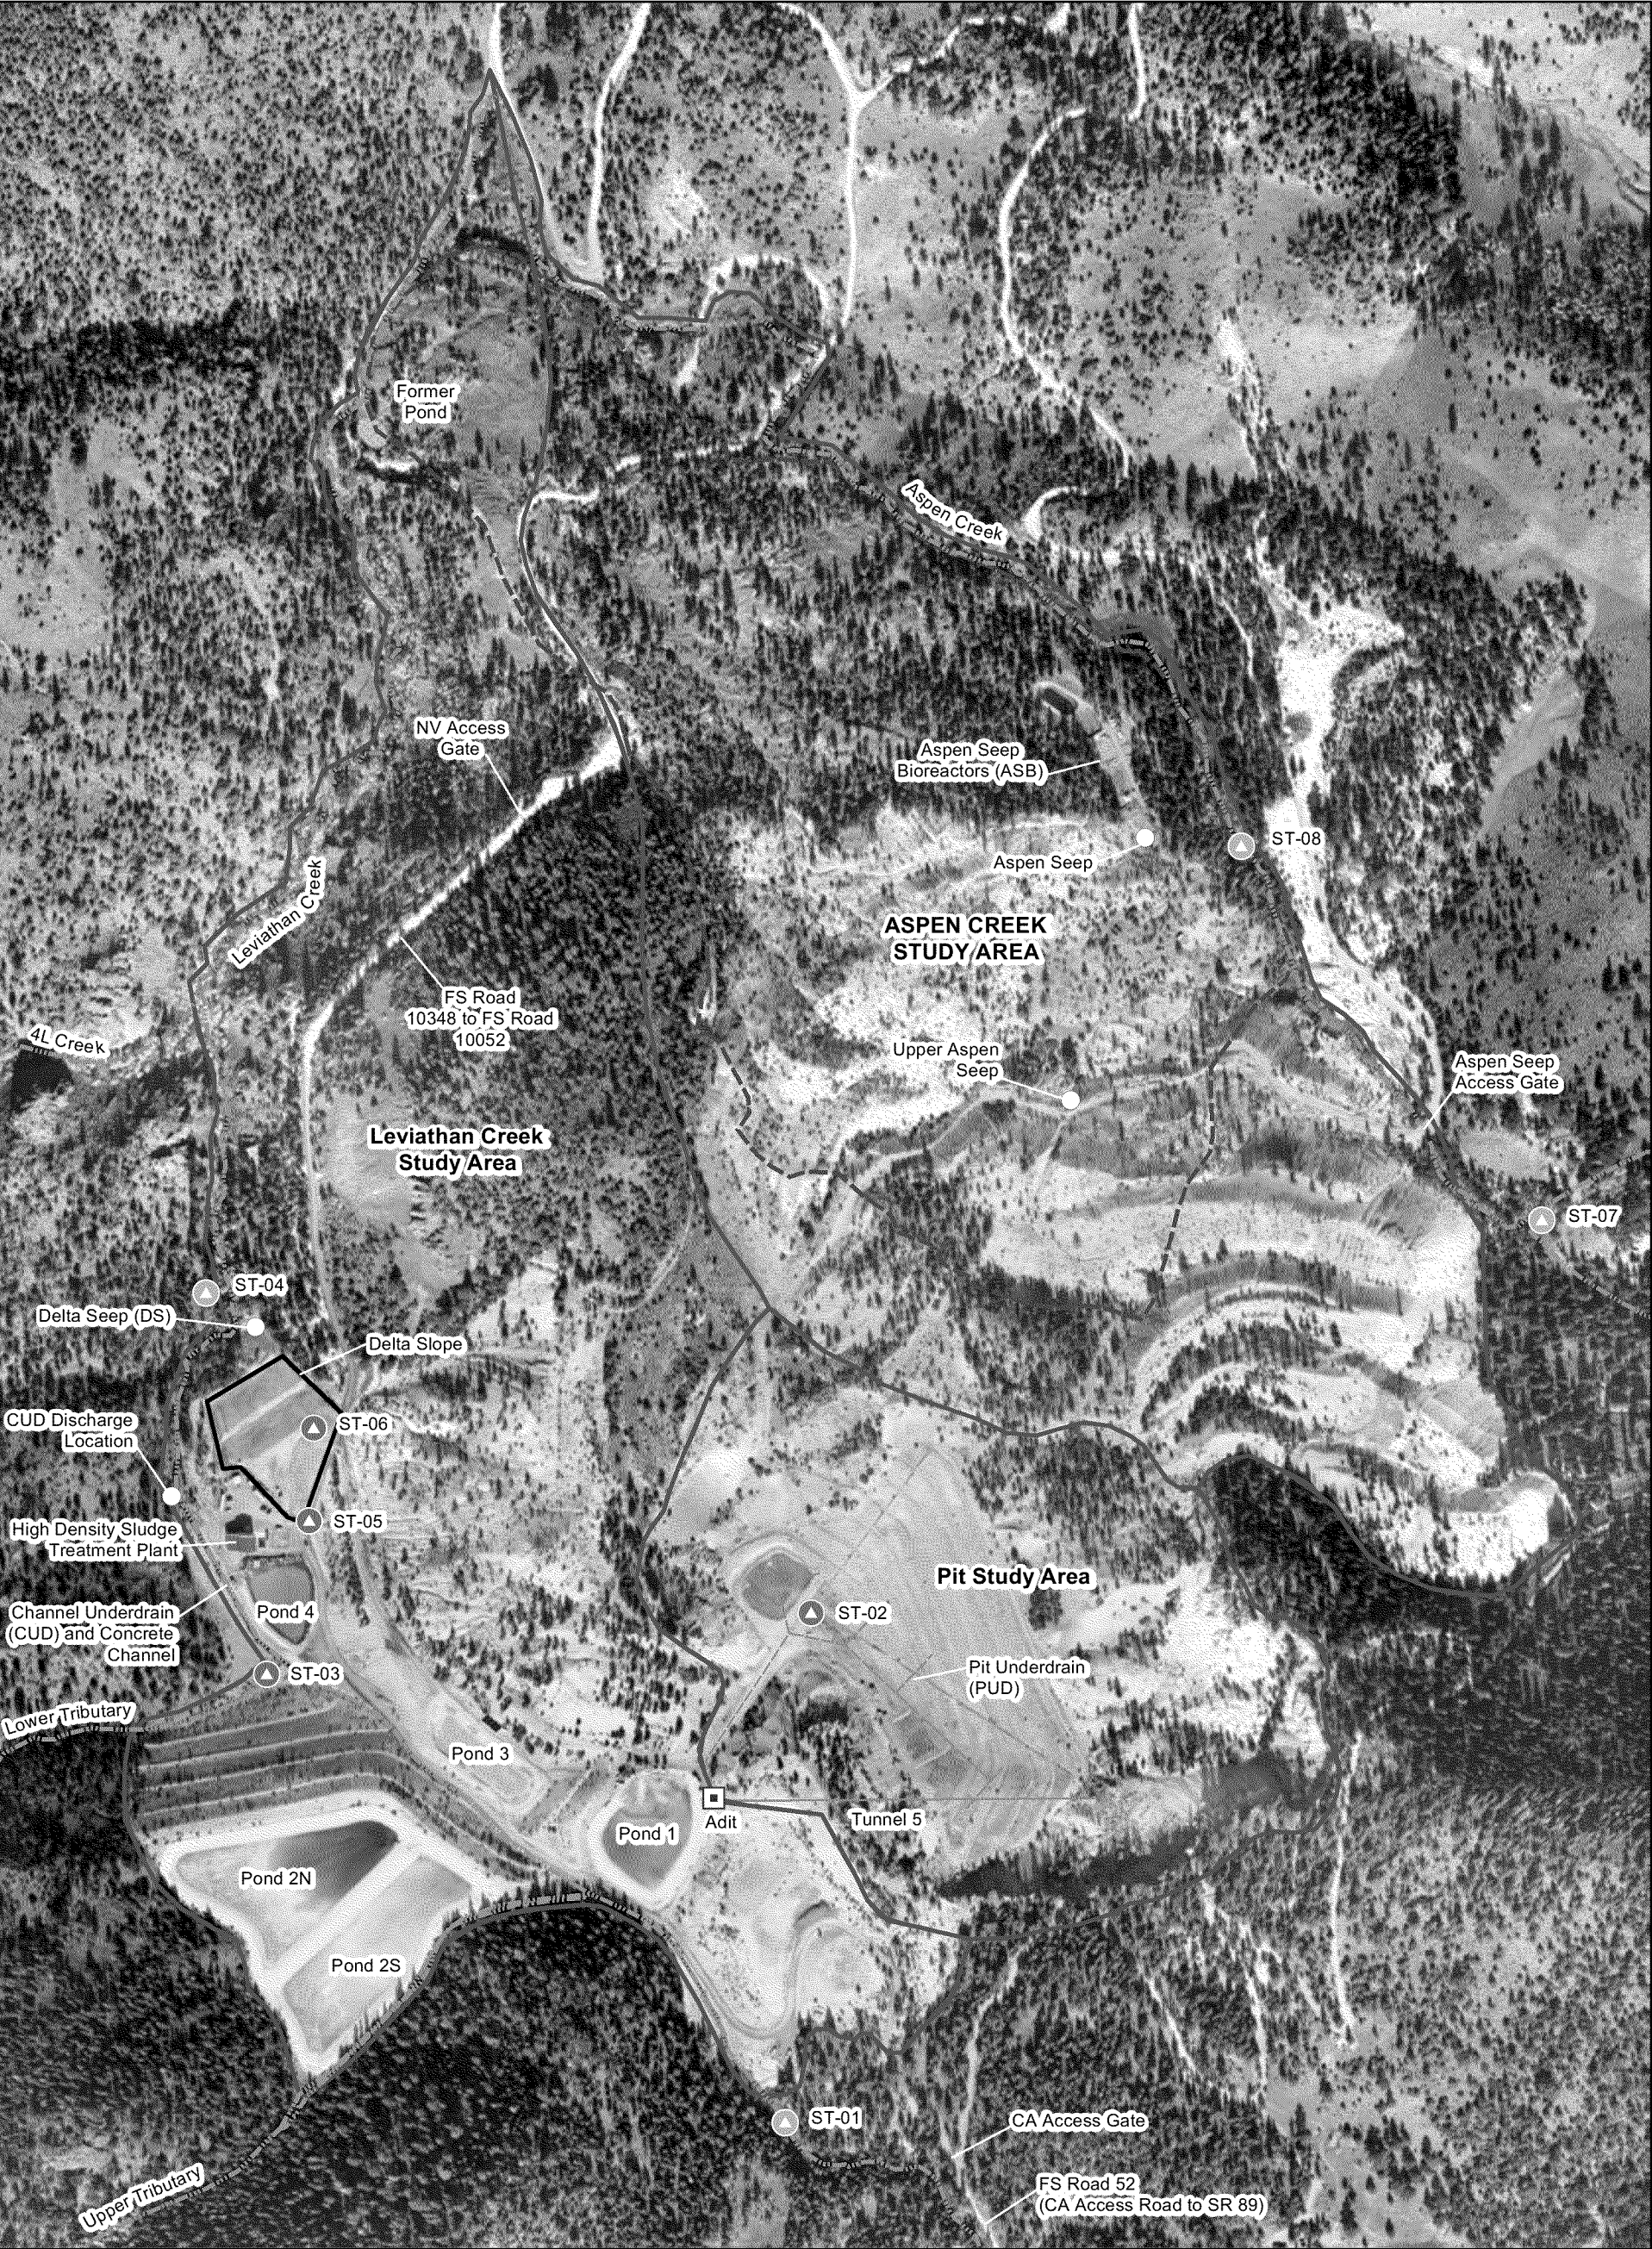
By: DPV Date: 03/31/2017	Project No. 0013091	
		Figure 1

Notes:
1. All locations and boundaries are approximate.
2. Base map from aerial photograph dated October 22, 2009.

STORM WATER MONITORING LOCATIONS Leviathan Mine Site Alpine County, California

The initial scoping for the snowmelt/storm water program was conservative in that many locations were selected to better understand the contribution from different physical features of the site. The monitoring network installed in 2011 consisted of six stations (ST-01 through ST-06) in the Leviathan Creek Study Area (LCSA) and the Pit Study Area (PSA) (Figure 1). Stations ST-01 and ST-04 are located on Leviathan Creek upstream and downstream of the disturbed area of the site, respectively. Stations ST-02, ST-03, ST-05, and ST-06 are located at strategic points throughout the surface water collection system to evaluate relative contributions from features in different portions of the LCSA and PSA. Monitoring stations ST-07 and ST-08 were added in the Aspen Creek Study Area (ACSA) (Figure 1) in 2015 as described in Amendment No. 3³ to the On-Property FRI Work Plan. Stations ST-07 and ST-08 are located on Aspen Creek upstream and downstream of the disturbed area, respectively.

At this time, the LRWQCB and its contractor have removed snow from Leviathan Mine Road and the site access road up to Pond 3, but snow has not been removed from the established roads and trails to the four snowmelt monitoring locations (Figure 1) and only one of the four monitoring locations (ST-07) is adjacent to a road. The other three monitoring locations (ST-01, ST-04, and ST-08) are only accessible by hiking on steep slopes or on trails adjacent to the creek. The road to station ST-07 and the roads that lead to the access trails for the other three locations are still covered in a thick layer of ice and snow, and it will not be safe to access these locations to re-install sampling equipment until more melting occurs or ice and snow can be removed with equipment.

For the 2017 field season, Atlantic Richfield is planning to collect snowmelt data at each of the four main storm water/snowmelt locations (ST-01, ST-04, ST-07, and ST-08). Atlantic Richfield is not planning to collect snowmelt samples at the four optional locations (ST-02, ST-03, ST-05, and ST-06). All snowmelt runoff from the PSA and LCSA discharges to Leviathan Creek and will flow by station ST-04. As a result, field parameter data and laboratory samples collected at station ST-04 can be used to adequately characterize the potential total effect that snowmelt originating in the areas of the Pit and the LCSA have on RI metals concentrations, pH, electrical conductivity, or temperature in runoff entering Leviathan Creek, which meets the objectives for the snowmelt runoff investigations as cited in the DQOs.

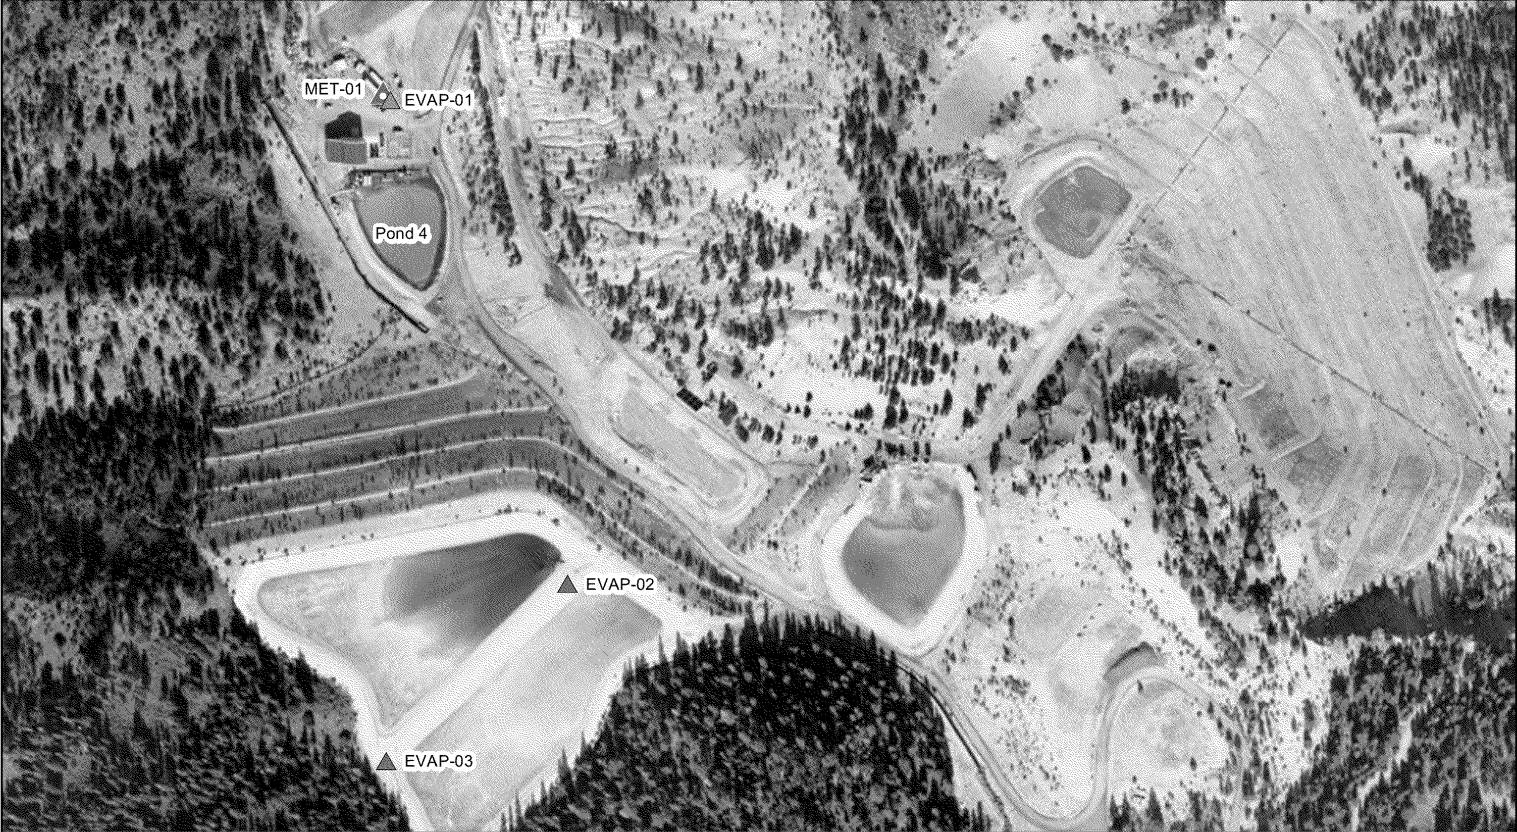
Figure
2

METEOROLOGICAL STATION AND
EVAPORATION PAN LOCATIONS
Leviathan Mine Site
Alpine County, California

The evaporation pan monitoring program originally consisted of monitoring evaporation rates at three evaporation pans (EVAP-01, EVAP-02, and EVAP-03), which were first installed in 2011 and are shown on Figure 2. Pan EVAP-01 was installed at the HDS/Pond 4 area and pans EVAP-02 and EVAP-03 were installed in the vicinity of Ponds 2N/2S. All three pans measured a change in water level, which was used to calculate an evaporation rate, and were removed from service each winter. In the Optimization Letter, Atlantic Richfield proposed (and U.S. EPA agreed in its letter dated September 11, 2015)⁵ to remove pans EVAP-02 and EVAP-03 from service because they were no longer needed to support the evaluation of pond leakage or the evaluation of potential microclimates. As such, pan EVAP-01 has been the only pan operating since 2015 with the intended purpose to collect data to support preparation of the water budget for the site.
